## 15.0 Salt Lake City, Utah, Disposal Site

### 15.1 Compliance Summary

The Salt Lake City, Utah, Disposal Site, inspected on April 2, 2007, was in good condition. The disposal cell, its cover materials, and associated surface water drainage features were in excellent condition. Removal of surface soil with historically elevated concentrations of  $\text{Ra}^{226}$  was performed along the property boundary on the east and west sides of the site by EnergySolutions, the adjacent radioactive waste disposal operator. Several radiological waste items found on site from EnergySolutions waste disposal operations were surveyed and determined to be uncontaminated. All surface radiological survey measurements taken on site during the inspection were below DOE Radiation Control (RadCon) Manual limits, indicating that spillover and windblown contamination from the adjacent EnergySolutions radioactive waste disposal operations is currently not an issue.

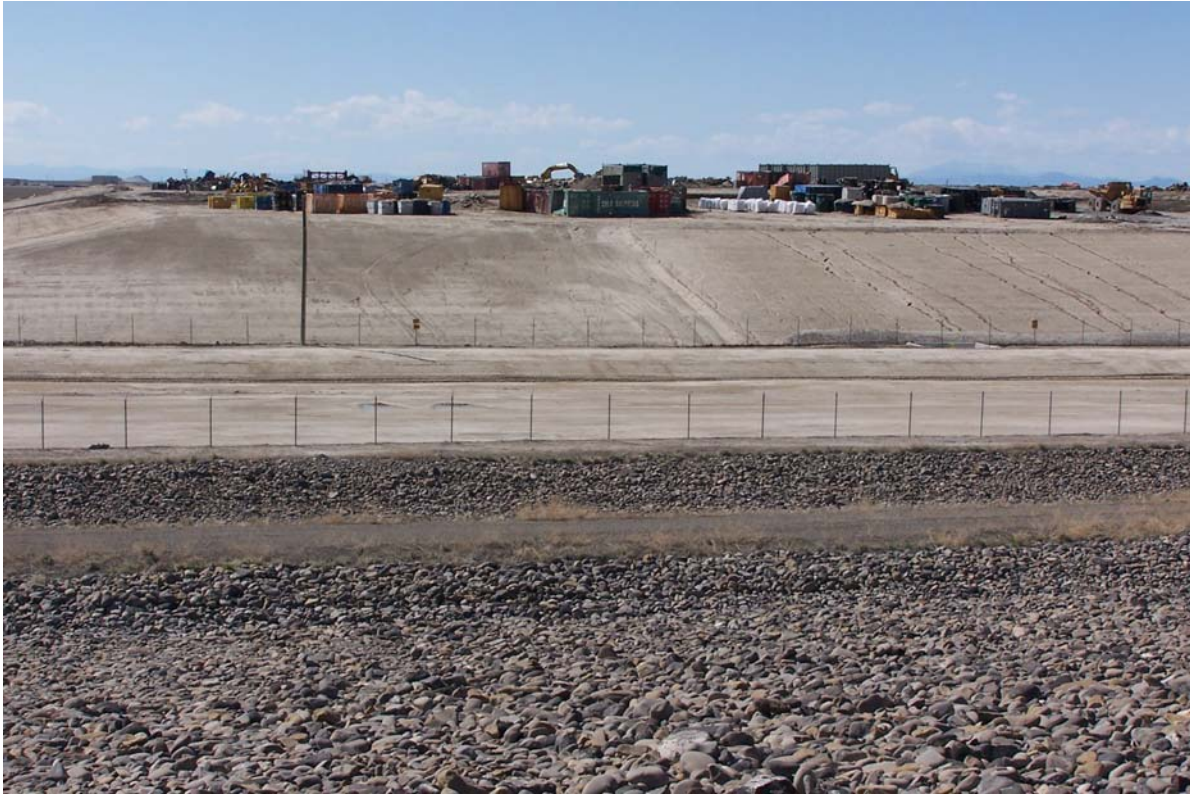
- 15A Access to the site is now along a route to the southwest corner of the property. Due to EnergySolution’s ongoing radioactive waste disposal activities on the surrounding property (PL–1), the adjacent haul roads currently used to access the southwest corner of the DOE site are designated as restricted areas (radiological control areas) and controlled by EnergySolutions. After being briefed by EnergySolutions health and safety personnel on the radiological hazards and controls in place for crossing these restricted areas, inspectors sign a radiological work permit and are issued dosimeters. EnergySolutions personnel then escort the inspectors to the site and accompany them during the inspection.

*SLC 4/2007. PL-1. EnergySolutions active waste disposal operations directly west of the site.*

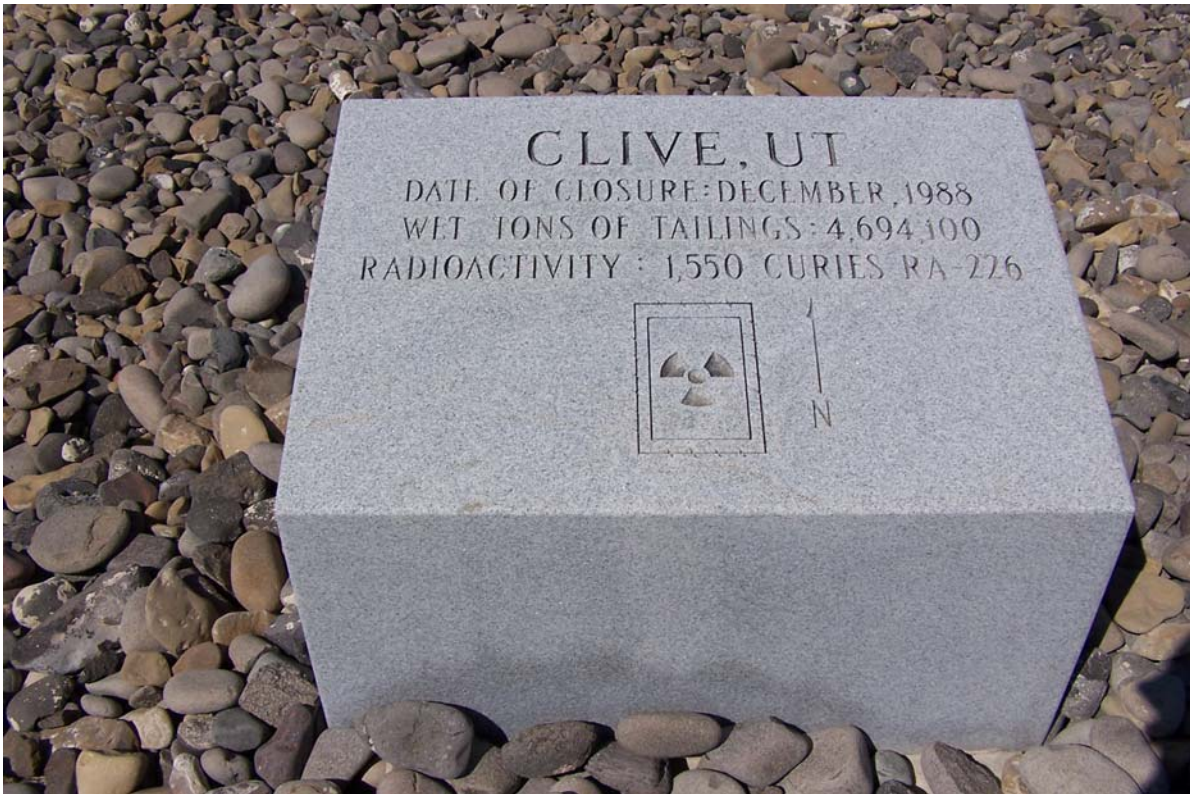
**Site Markers and Monuments**—Two granite site markers are placed at the site, one located at the site entrance in the northwest corner and one located on the disposal cell top (PL-2); both were in excellent condition. Four boundary monuments are located on the property, one in each corner; all were in good condition.

*SLC 4/2007. PL-2. Site marker SMK-2.*

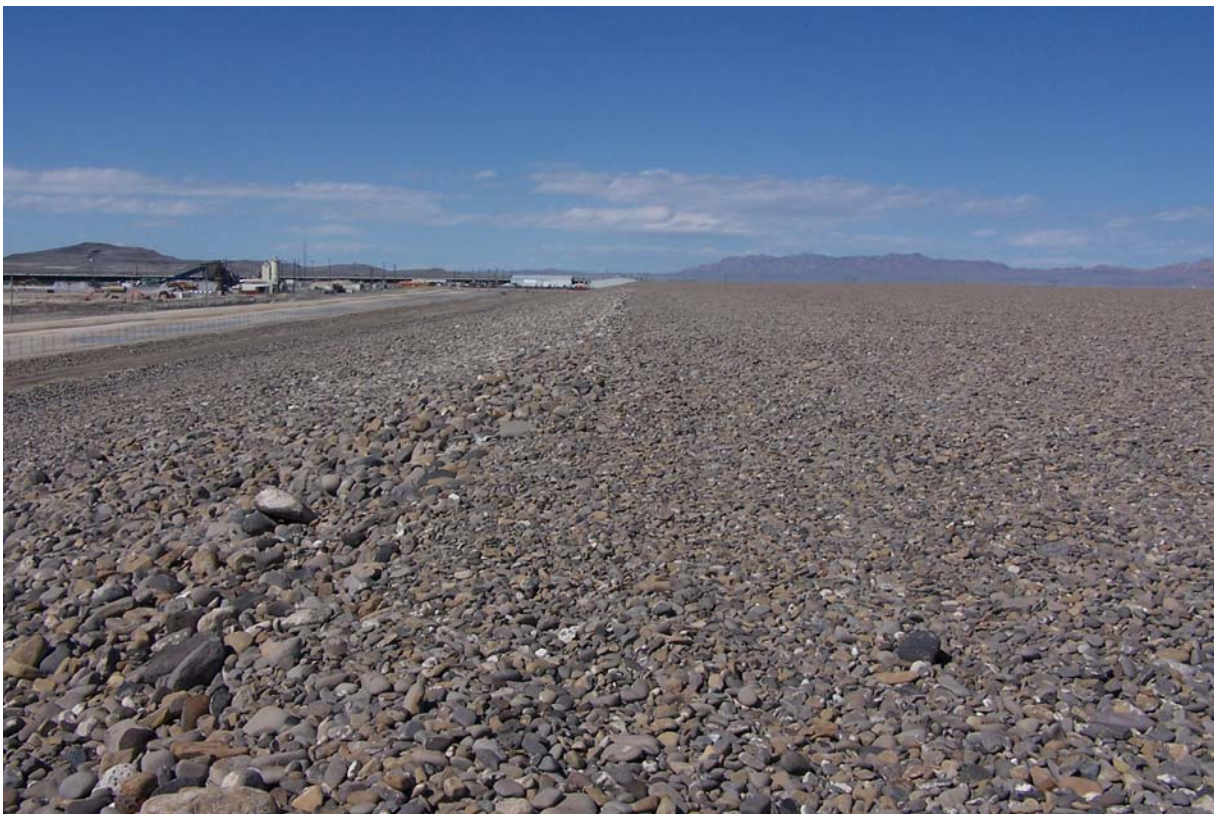
**Top and Side Slopes of the Disposal Cell**—The top and side slopes of the disposal cell are armored with riprap and were in excellent condition (PL-3). Three very slight depressions were noted on the cell top in 2006 that had not been noticed in prior inspections. These slight depressions are likely from the initial construction of the cell and not from post-construction settling. Water does not appear to be ponding and DOE will continue to monitor the area. Inspectors found no evidence of settling, slumping, or instability on the top and side slopes of the disposal cell. No deep-rooted plants were found growing on the disposal cell cover.

*SLC 4/2007. PL-3. View north showing the crest of the west side slope and top of the disposal cell.*

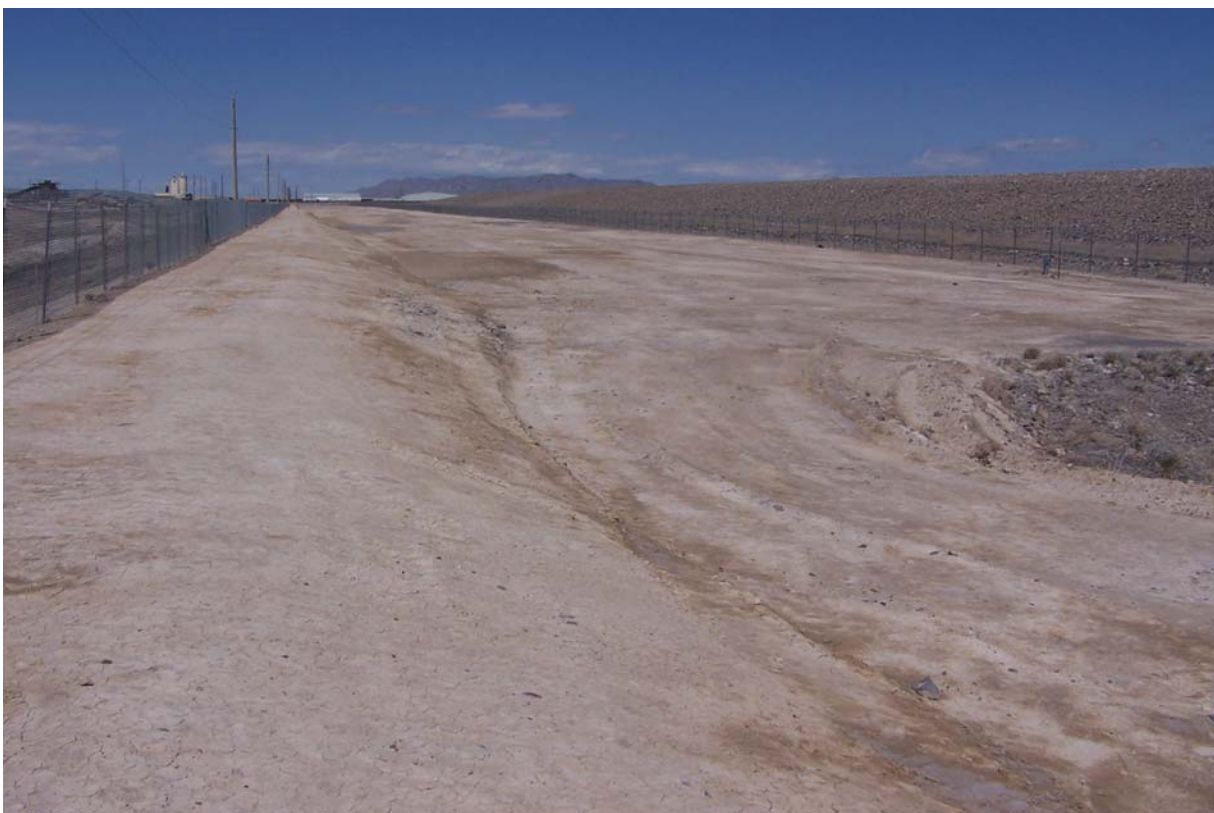
15C In December 2006, EnergySolutions notified DOE that they had removed surface soil (~1 ft in depth) in the area between the property boundary and DOE's interior disposal cell security fence along the entire length of the east and west property boundaries. The post-closure survey performed by the Utah DRC in 1989 reported concentrations of  $Ra^{226}$  remaining in surface soil in these areas in excess of the 5 pCi/g limit EnergySolutions is required to maintain on their property. The post-closure survey reported  $Ra^{226}$  concentrations up to 27 pCi/g. Because of concerns DOE expressed over the potential for spillover contamination on to the disposal site from EnergySolutions operations, removal of this surface soil was performed in order to enable determination as to whether spillover was occurring in the future. The  $Ra^{226}$  concentrations reported in the post-closure survey report are believed to have been a remnant of the initial construction of the DOE disposal cell, because EnergySolutions active radioactive waste disposal operations had not yet begun. EnergySolutions disposed of the surface soil removed and placed clean fill material in the remediated areas and graded the surface (PL-4) at no cost to DOE. All surface radiological survey measurements taken within the remediated areas were below DOE RadCon Manual limits for posting a contamination area.

*SLC 4/2007. PL-4. Area between the property boundary and the security fence along the west side of the site.*

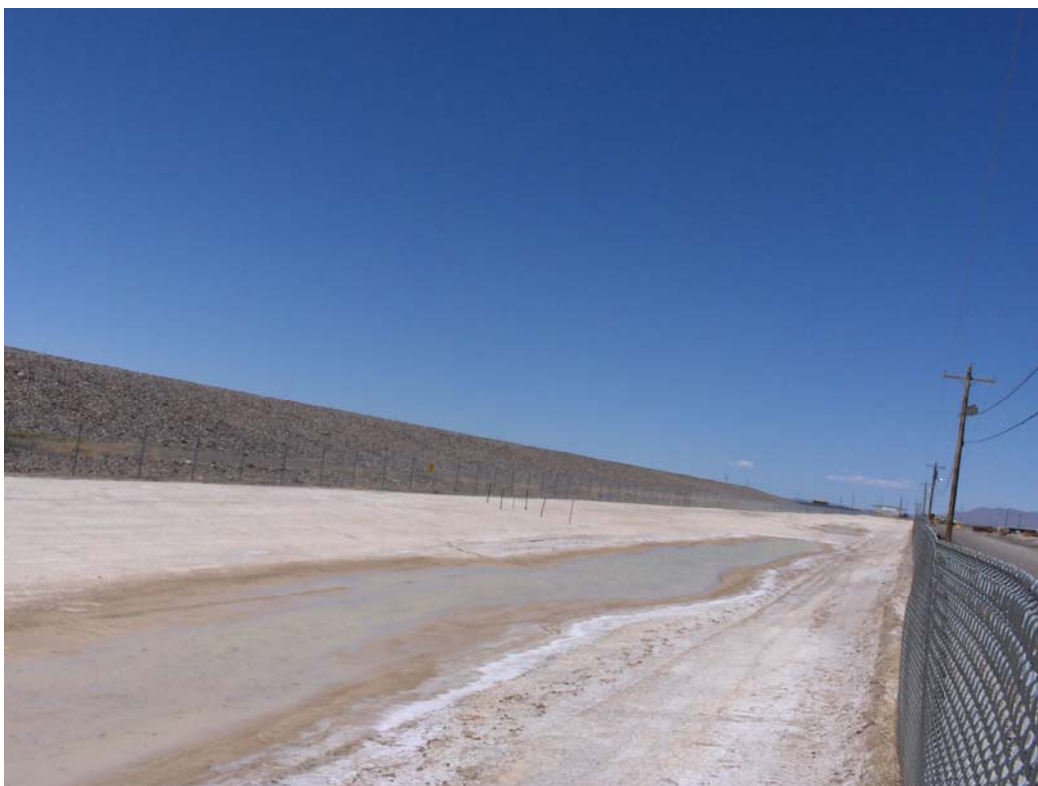
15D The Utah DRC notified DOE on June 7, 2007, that EnergySolutions implemented their Emergency Response Plan to address a breach of a restricted area containment berm west of their low-level radioactive waste (LLRW) container pad. Approximately 500 gallons of potentially contaminated non-contact stormwater flowed onto the site, into the buffer area on the east side of the site between the disposal cell security fence and the EnergySolutions fence that defines the property boundary. On June 13, 2007, DOE was informed that gamma spectroscopy analysis of samples collected from the ponded stormwater on DOE's property reported background levels of radiation. It was also reported that the restricted area non-contact stormwater had flowed into an estimated 84,000-gallon pool of stormwater (approximately 25 ft wide by 450 ft long by 1 ft deep) located on DOE's property that was the result of a significant precipitation event. As part of their Emergency Response Plan, EnergySolutions fortified the berm with clay and pumped all ponded stormwater on DOE's property to their evaporation ponds. No erosion or damage to the site occurred; photographs were provided by EnergySolutions for documentation (PL-5), along with a copy of the follow-up correspondence to the Utah DRC.

*SLC 4/2007. PL-5. Standing water in the buffer area between the disposal cell security fence and the property boundary on the east side of the site.*

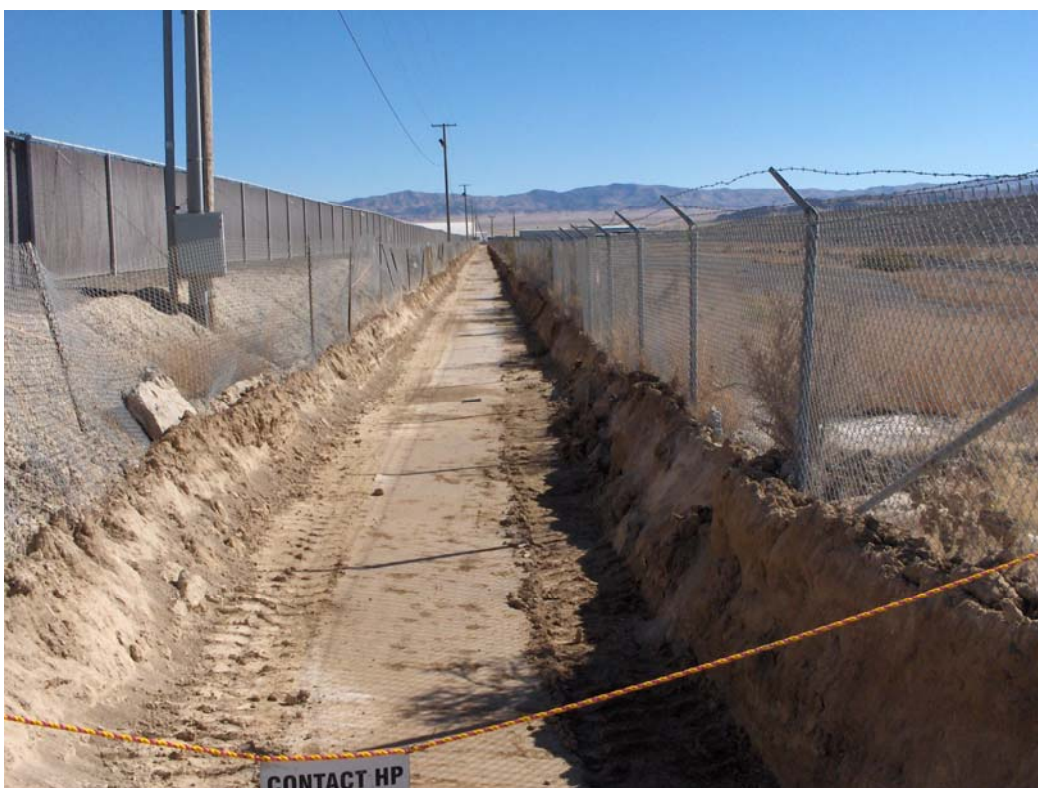
In 2005, on the north side of the site between the DOE property boundary (defined by the chain-link security fence) and the EnergySolutions restricted area waste haul road fence, several locations were found during the inspection to have been excavated approximately one foot and posted as radioactive materials contamination areas. The contamination resulted from activity performed on the EnergySolutions waste haul road adjacent to the site. EnergySolutions removed the contaminated surface soil in these areas and installed matting on the waste haul road fence to help reduce future contamination. In 2006, these areas had not been back-filled or de-posted; the barrier ropes and warning signs were observed lying on the ground. In 2007, it was observed that EnergySolutions had remediated the entire length of the area between the fences (from east to west) directly north of the property to a depth of approximately two feet; radiological postings remained at the time of the inspection (PL-6). Surface radiological survey measurements were taken on DOE's property just inside the perimeter fence adjacent to this remediated area. All measurements were below DOE RadCon Manual limits for posting a contamination area.

*SLC 4/2007. PL-6. Remediated area directly north of the site property boundary between the site security fence and EnergySolutions' waste haul road fence.*
